Fatal Collision Causation and Potential Countermeasures

Joseph Chan
Pella LeDrew
Transportation Centre
University of Saskatchewan

Alan German
Transport Canada

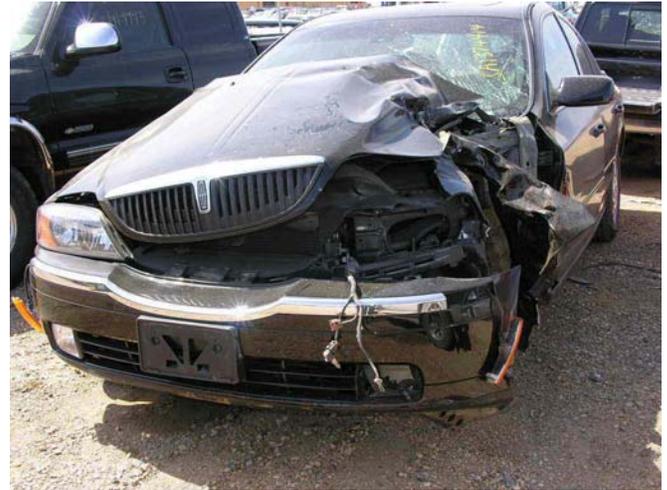
A 1992 Honda 900 RR Fireblade motorcycle was travelling westbound along the intersecting road at an estimated speed of 136 km/h, well in excess of the posted 50 km/h limit. As the Lincoln entered the intersection, the front wheel of the motorcycle impacted the car's left-front side (Figure 1).

The impact by the motorcycle broke the left-front wheel assembly away from the Lincoln and resulted in 39 cm of crush to the vehicle's side structure. The Lincoln rotated clockwise out of the impact and moved diagonally across the intersection. The car, its detached front wheel, and the motorcycle, all came to rest in the southwest corner of the intersection. The motorcycle's rider came to rest along the southwest sidewalk, to the west of the Lincoln. His motorcycle helmet became detached in the

Figure 1: Damage to the Lincoln from the Honda Motorcycle

| Case | Location | Configuration | Contributing Causal Factors | Potential Countermeasures |
|---|---|---|--|--|
| 1 | Urban | T-collision | Excessive speed Motorcycle conspicuity | Speed enforcement Education |

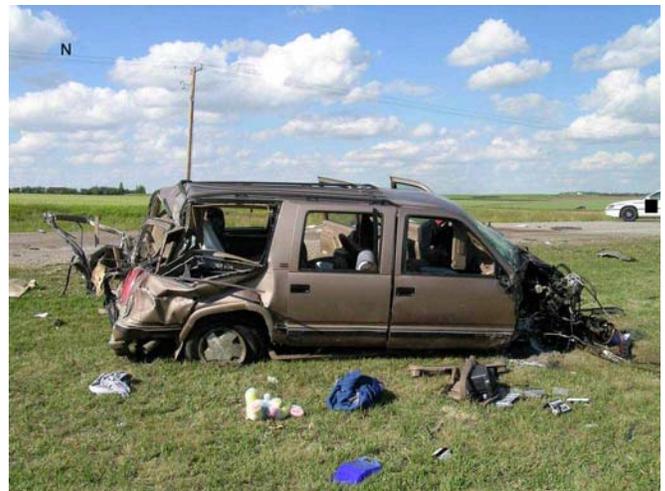
The front of the Suburban was extensively damaged, with a maximum crush of 54 cm at the right-front bumper. The right front wheel assembly was separated from the vehicle. The impact also caused severe damage to the Kenworth's steering axle. The Suburban rotated counter-clockwise out of the initial impact, and its right-rear corner struck the left side of the hopper trailer, just in front of the trailer's 4th axle. This second impact resulted in extensive damage to the right-rear side of the Suburban. The rear windows were broken and the right D-pillar was badly deformed, with a maximum crush of 66 cm (Figure 2).

Figure 2: Damage to the D-Pillar Area of the 1995 GMC Suburban

A 12-year-old male was seated on the right side of the third row seat in the vehicle. Although this occupant was fully restrained, his skull was crushed as a result of direct contact with the intruding hopper-trailer and he was fatally injured.

| Case | Location | Configuration | Contributing Causal Factors | Potential Countermeasures |
|---|---|---|--|--|
| 5 | Rural undivided highway | Head-on | Fatigue | Vehicle stability control system Lane departure warning system Driver fatigue warning system Rumble strips |

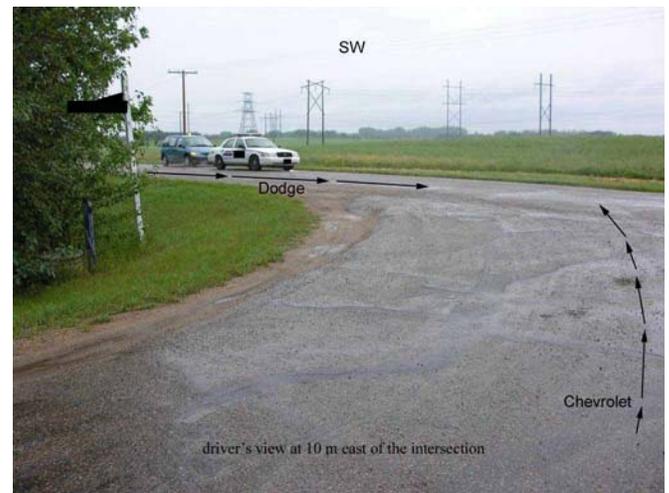
A 1994 Chevrolet Cavalier four-door sedan was westbound on an intersecting two-lane road. The Cavalier arrived at a T-intersection with the major road that was controlled by a yield sign. Visibility between northbound and westbound traffic was limited by a stand of trees in the south-eastern corner of the intersection. In addition, the yield sign for westbound traffic was located 10 m to the east of the intersection, so that Cavalier's driver, when stopped at the yield sign, could only see about 40 m of the main road to the south (Figure 3).

Figure 3: Limited Visibility at the Intersection

| Case | Location | Configuration | Contributing Causal Factors | Potential Countermeasures |
|---|---|---|--|--|
| 7 | Suburban local | Angle | Limited intersection sight distance Failed to yield Inattention | Increase sight distance at intersection Defensive driving techniques |

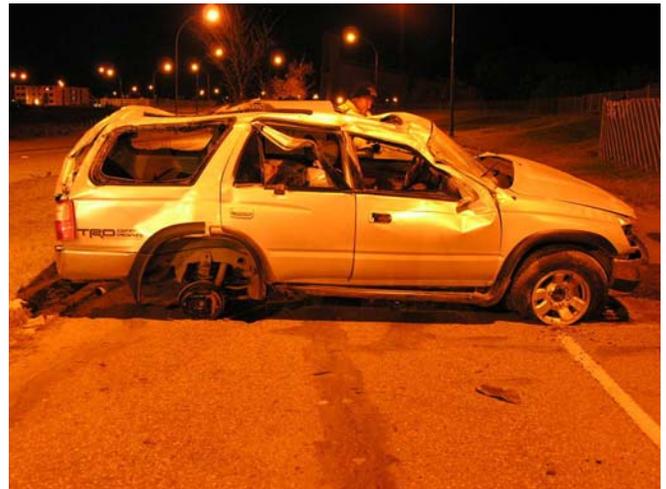
Figure 4: 1998 Toyota 4Runner

The 17-year-old, female driver was alcohol impaired, with a blood alcohol level of 240 mg%. She had traces of cannabis in her system, and was using anti-depressant medication. As the vehicle rounded a shallow curve to the right, it began to yaw clockwise. The driver was unable to regain directional control. The vehicle mounted the right curb, and ran onto the grass-covered boulevard. The driver over-steered to the left, putting the vehicle into a counter-clockwise yaw. The 4Runner tripped and rolled over twice, crossing the adjacent travel lanes, and the median, before coming to rest on its wheels on the far side of the roadway (Figure 4).

The driver was unrestrained and was completely ejected from the vehicle during the rollover sequence. She received fatal injuries including a fractured skull and crush to the chest and abdomen, with fractured ribs and lacerations to multiple internal organs.

| Case | Location | Configuration | Contributing Causal Factors | Potential Countermeasures |
|---|---|---|--|--|
| 10 | Urban divided | Rollover | Alcohol & drug Excessive speed Inexperienced driver | Vehicle stability control system Speed enforcement Seat belt use |

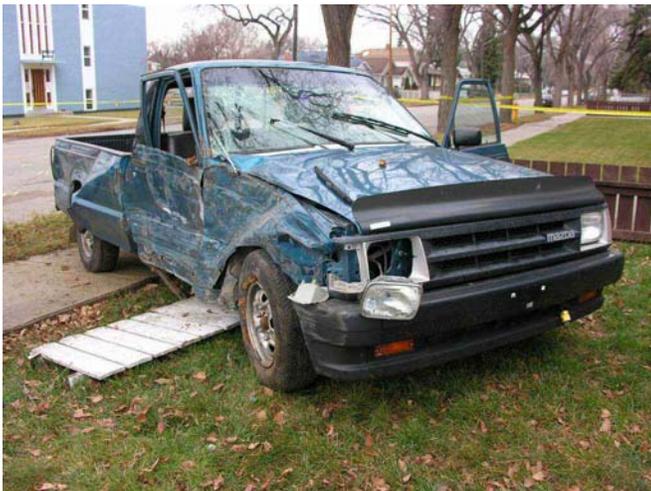
The Mazda sustained damage along both the right-front fender and right-side door as a result of the impact with the tree (Figure 5). A maximum crush of 19 cm was measured at the front edge of the right door. The right side window was broken and the right door was jammed as a result of the impact.

Figure 5: Damage to the Right Side of the 1993 Mazda B2200

| Case | Location | Configuration | Contributing Causal Factors | Potential Countermeasures |
|---|---|---|--|--|
| 11 | Urban undivided | Side-swipe | Alcohol Speeding Fatigue | Vehicle stability control system Seat belt use |
