Air Bag Induced Fatalities in Canada

Alan German
Dainius Dalmotas
Suzanne Tylko
Jean-Louis Comeau
Brian Monk
Road Safety and Motor Vehicle
Regulation Directorate
Transport Canada

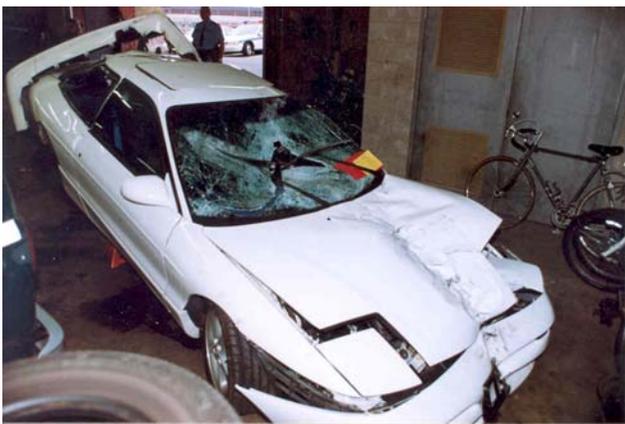
Figure 1. 1993 Ford Probe

A 1993 Ford Probe GT two-door hatchback ran into the gore area of a Y-intersection. The front of the vehicle initially struck a metal sign post (12FCAN6), then sideswiped a large diameter pole supporting an overhead sign (11LDAW2).

The 37-year-old, male driver was unrestrained. He sustained massive head and chest injuries that included: avulsion of the brain stem; fracture and dislocation of the odontoid process of C2; complex fracture of the basal skull; complex laceration of the spleen and right lobe of the liver; and flail chest.

The collision circumstances suggest that the driver, who was alcohol-impaired, had passed out and was slumped forward over the steering wheel when the air bag deployed. [4]

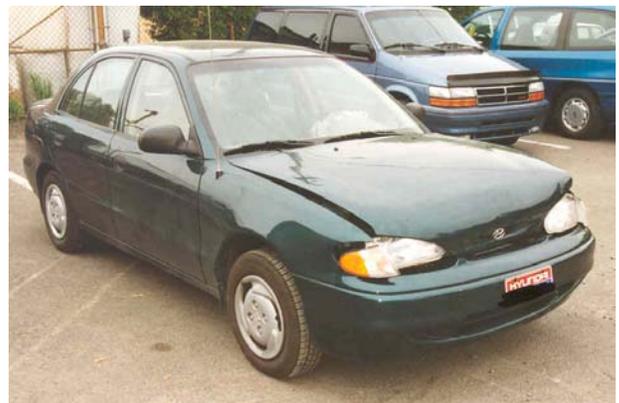
Figure 2. 1995 Hyundai Accent

The case vehicle, a 1995 Hyundai Accent four-door sedan, was travelling southbound on an urban arterial. A 1992 Honda Civic, travelling ahead of the case vehicle, stopped in traffic. The driver of the Accent braked; however, the front of his vehicle struck the rear of the Civic. Minor damage resulted to the front bumper and hood of the Accent (12FDEW1). The corresponding direct damage to the rear of the Civic was limited to the rear bumper assembly, with induced damage to the spare wheel well (06BDLW1).

As a result of the deployment of the right-front air bag, the child received a large abrasion to the right side of the neck and face, and a thermal burn to the right cheek. Complete dislocation of the spine, at C1 and the base of the cranium, was accompanied by complete transection of the spinal cord, and a large haematoma in the region of C1-C7. The right atrium of the heart was bruised, and portions of skin were avulsed from the little finger and wrist of the right hand. In addition, there was head contact with the floor-mounted transmission shift lever resulting in a contusion to the occipital region.

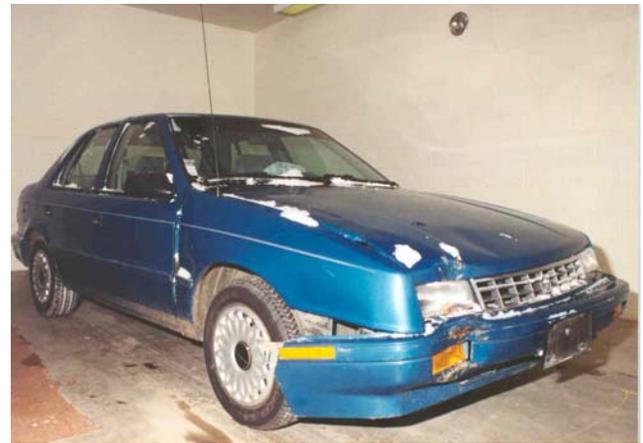
Figure 3. 1994 Plymouth Sundance

concentrated on the vehicle's front bumper and grille (12FREN1), with a maximum crush of 18 cm.

The autopsy indicated minor contusions to the right upper arm, left arm and to the left chest. Death resulted from a 0.6 cm tear to the root of the left main pulmonary artery with cardiac tamponade. The pathologist noted that there was no pre-crash degeneration of the arterial tissue.

The driver's blood alcohol content was found to be at the legal limit. This fact, in combination with the shallow angle of departure from the roadway, the lack of evasive action, and the injury pattern to the thorax, led to the conclusion that the driver had fallen asleep and was slumped directly on top of the air bag module at the time of collision. [6]

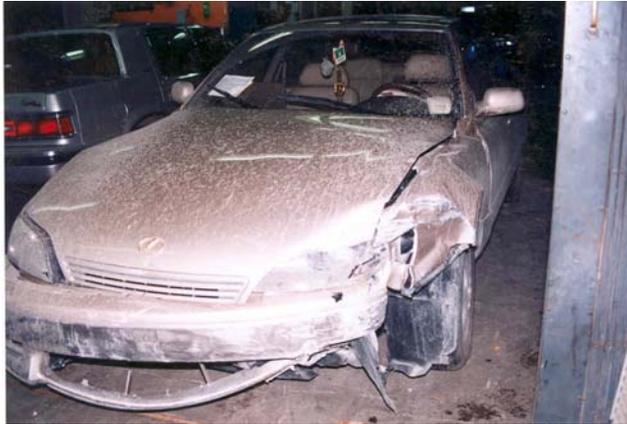
Figure 4. 1996 Lexus ES300

striking a small sapling, breaking through two wooden fences, and finally impacting the corner of a garage. The latter impact resulted in 19 cm of crush to the left-front bumper (12FLEW1) and the deployment of both front air bags.

The driver of the Lexus was a fully-restrained 44-year-old female. The investigating police officer indicated that the driver's seat was positioned close to the steering wheel. Subsequent detailed examination of the air bag assembly identified cosmetic transfers on both the air bag cover and fabric. These witness marks indicated that the driver's head was in extremely close proximity to the air bag module at the time of deployment.

The driver was unresponsive at the collision scene. She was transported to hospital where attempts at resuscitation were unsuccessful. No autopsy was conducted. The cause of death was stated as closed head injury. Other recorded injuries were contusions to the face, chest, and upper right arm, and a burn to the middle and index fingers of the left hand. [7]

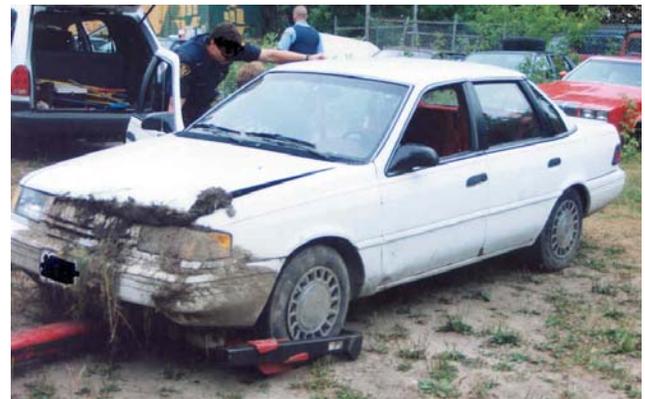
Figure 5. 1992 Ford Tempo

The Tempo's driver also braked, but lost directional control. The car crossed the centre line and entered the east ditch. The front of the Tempo struck the back slope of the ditch (12FDEW1); however, there was no measurable crush. As a result of the impact, the driver's air bag deployed.

The driver sustained a comminuted fracture of the left lateral mass of C1, multiple bilateral rib fractures, a lacerated aorta, a fractured sternum, minor contusions, lacerations and abrasions to the face, chest and extremities. [7]

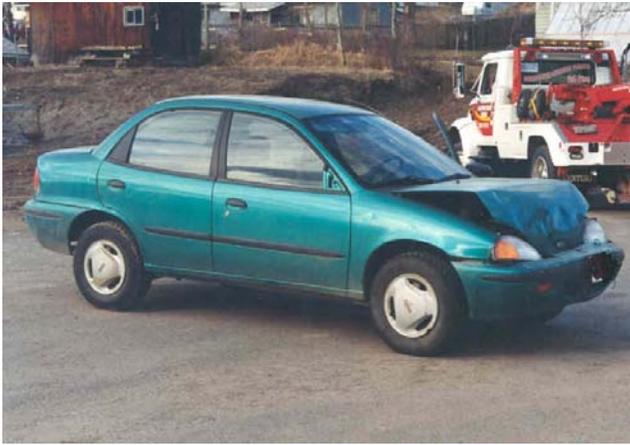
Figure 6. 1995 Geo Metro

The Sunbird sustained damage across the entire rear bumper (06BDLW1). The maximum crush was approximately 15 cm at the right rear corner. The Geo Metro sustained direct damage to the front bumper, headlights, and hood, across the full width of the car, with a maximum crush of 5 cm, measured at the centre of the vehicle (12FDEW1). Both front air bags in the Geo Metro deployed in the crash.

The 13-year-old female sustained a minor laceration to her face, while the 13-month-old male was fatally injured. The injuries to the infant included anterior displacement of C4-C5 with complete transection of the spinal cord; a subdural haematoma; abrasions and contusions to the face.

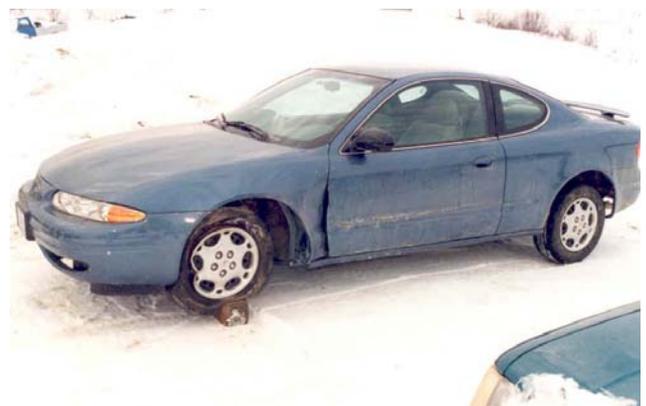
Figure 7. 1999 Oldsmobile Alero

Near the bottom of the embankment, the left front wheel struck a large rock, breaking the left aluminum control arm. The vehicle continued forward and the front cross-member of the engine cradle struck another protruding rock. The cross-member was displaced rearwards approximately 5 cm (00UFCW1). The event data recorder (EDR) in the vehicle indicated a ΔV of 15 km/h resulting in deployment of the driver's air bag.

The driver expired six hours after arriving at the hospital. Results from a post-mortem examination indicated that the driver had sustained a diffuse subarachnoid haemorrhage, bilateral coning of the cerebellar tonsils, subluxation of the atlanto-occipital joint, and diffuse contusions of the upper cervical spinal cord at C1-C2. In addition there was a periorbital haematoma to the left eye, a contusion to the left eyebrow, and bruising to the extremities.

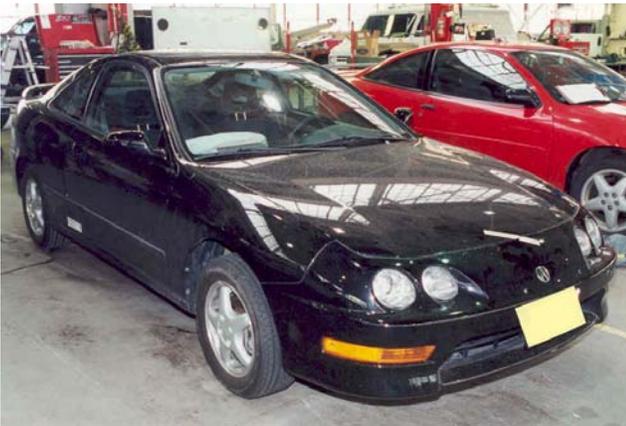
Figure 8. 2000 Acura Integra

The double hit to the Acura resulted in minor damage to both the rear and front ends of the vehicle, with no measurable crush to the exterior of either bumper. Deformation of the structures under

the bumper fascias measured approximately 1 cm (12FDLW1). An on-board event data recorder indicated a ΔV for the frontal impact of 19 km/h, resulting in deployment of the driver's air bag.

The steering column showed evidence of loading in the form of partial shear capsule separation. There was an abrasion from the air bag on the windshield wiper stalk. There was trace evidence of occupant head contact on the windshield, and a knee contact on the lower portion of the steering column shroud. The driver's seatback was twisted clockwise.

The driver was found in the vehicle, unconscious, and bleeding from the nose. When emergency rescue personnel arrived at the scene, the driver had no vital signs. Results from an autopsy indicated that the driver has sustained complete transection of the aorta at the level of the 5th intercostal arteries; bilateral rib fractures; a fractured sternum; bilateral haemothoraces; small lacerations along the lower border of the spleen; mesenteric bruising to the left upper quadrant of the intestine; mediastinal haemorrhage; a laceration of the oral mucosa, to the left of the upper median frenulum; periesophageal haemorrhage; an abrasion to the anterior neck; abrasions and contusions to the left elbow. No skull fracture was observed, the brain anatomy was normal, and the vertebral column, including the cervical spine, was intact.

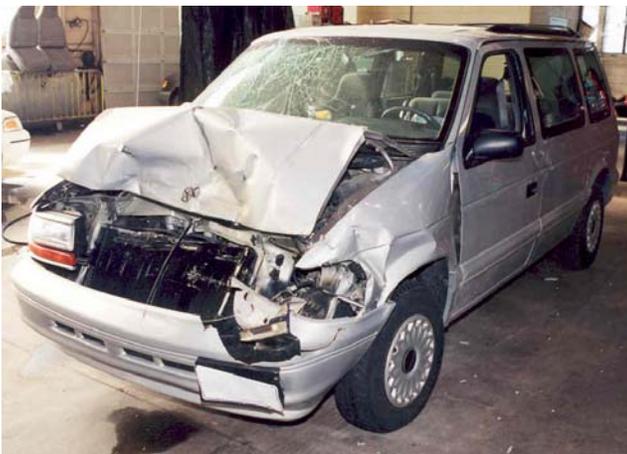
Figure 9. 1994 Plymouth Voyager

The underride impact configuration resulted mainly in damage above the Plymouth's bumper. The hood was buckled, and the upper radiator support was deformed rearward against the engine. A maximum crush of 38 cm was recorded at the level of the edge of the hood. There was direct contact to the rear bumper of the GMC pickup truck, with a maximum crush of 3 cm.

Based primarily on the damage to the collision-involved vehicles, a pre-impact speed of 30 km/h was estimated for the Plymouth, with a corresponding ΔV of 18 km/h. Both front air bags in the Plymouth deployed in the crash.

Inspection of the child's lap/torso restraint system revealed very faint striations in the main slot of the modified locking tongue, and on the locking bar. In addition, bloodstains were located on a portion of the webbing that would have been in the retracted position, had the seat belt not been extended. The adjustable D-ring was in the highest position.

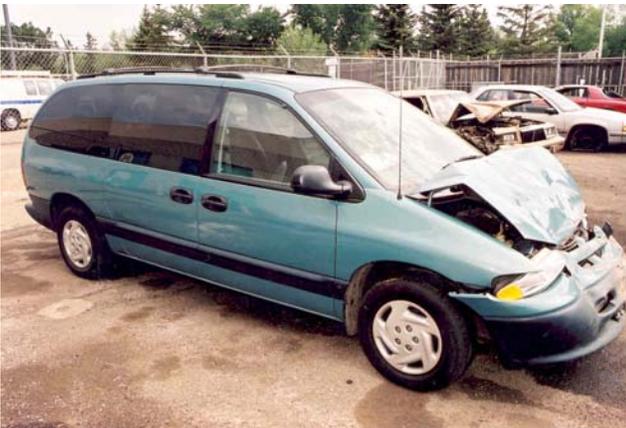
Figure 10. 1997 Dodge Grand Caravan

The Caravan sustained direct contact damage to the front bumper and grille area. At bumper level, the damage was mainly to the fascia. The steel bumper reinforcement beam behind the fascia sustained minimal damage. Above-bumper components such as the hood, grille, the radiator, the radiator support, the leading end of the front left fender, and the left

headlight assembly all sustained damage. A maximum crush of 20 cm was measured at the level of the radiator support. Contact to the Explorer was to the rear bumper with a maximum crush of 10 cm.

Examination of the seat belt system identified a number of witness marks on the seat belt tongue and D-ring. Blood stains on the webbing were located in an area which, with the lap belt extended across the child's waist, would have been close to the seat belt buckle assembly. Abrasions located on the plastic coating of the seat belt tongue were consistent with occupant loading of the system in the collision. No corresponding transfers on the lap

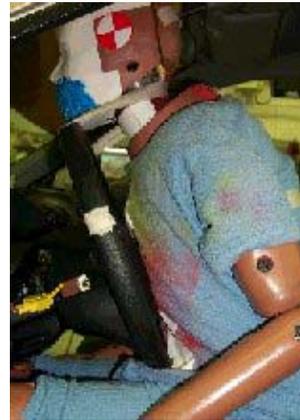
Figure 11. Chest-on-module out of position test

The pattern and severity of the thoracic trauma sustained by the Acura's driver were consistent with the results of the tests when the dummy was in close proximity to the air bag module at the time of deployment. In particular, the rib deflections measured on the dummy were of the order of 50 mm, a level which could well result in major chest injury.

The case collision was of low severity and the fatal thoracic injuries sustained by the driver of the Acura resulted from forces applied to the chest by the deploying air bag.

The test results suggest that increasing the distance between the dummy chest and the air bag module by as little as 50 mm reduced the peak thoracic deflections of the dummy by approximately half. A properly worn seat belt may have provided sufficient restraint to prevent the driver from entering into such close proximity to the air bag module.

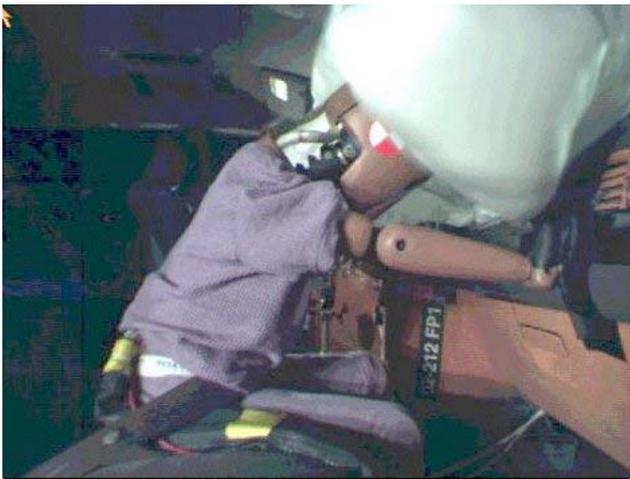
Figure 12. Air bag interaction with head of child dummy

The conclusive test set up consisted of the Hybrid III 6-year-old dummy seated in the centre of the front passenger seat, flexed at the hips to the extent possible, and with the arms extended. The hands of the dummy were secured to the dashboard on either side of the air bag door opening to simulate inertial loading. The dummy's chin was raised, though to a smaller degree than would be expected in the case of a child. The dummy's neck is significantly stiffer than that of a child and will not extend, or allow the chin to point upwards easily. Forcing the dummy's chin up applies a pre-load to the neck, which can confound neck response values. Thus, the position achieved is perhaps not ideal but, nevertheless, is still considered representative. The use of the Q6 6-year-old dummy was abandoned due to its inability to be installed in a position representative of the male child in the subject collision.

Damage to the interior of the vehicle was replicated only in the final, conclusive test with the arms braced. In the absence of such bracing of the arms, the bag tends to deploy immediately downwards, tearing the lower corners of the vinyl surrounding the air bag opening. The air bag must be deflected
