# The Use of Event Data Recorders in the Analysis of Unintended Acceleration Incidents

Trevor Lehouillier William Holmes Transport Canada

# ABSTRACT

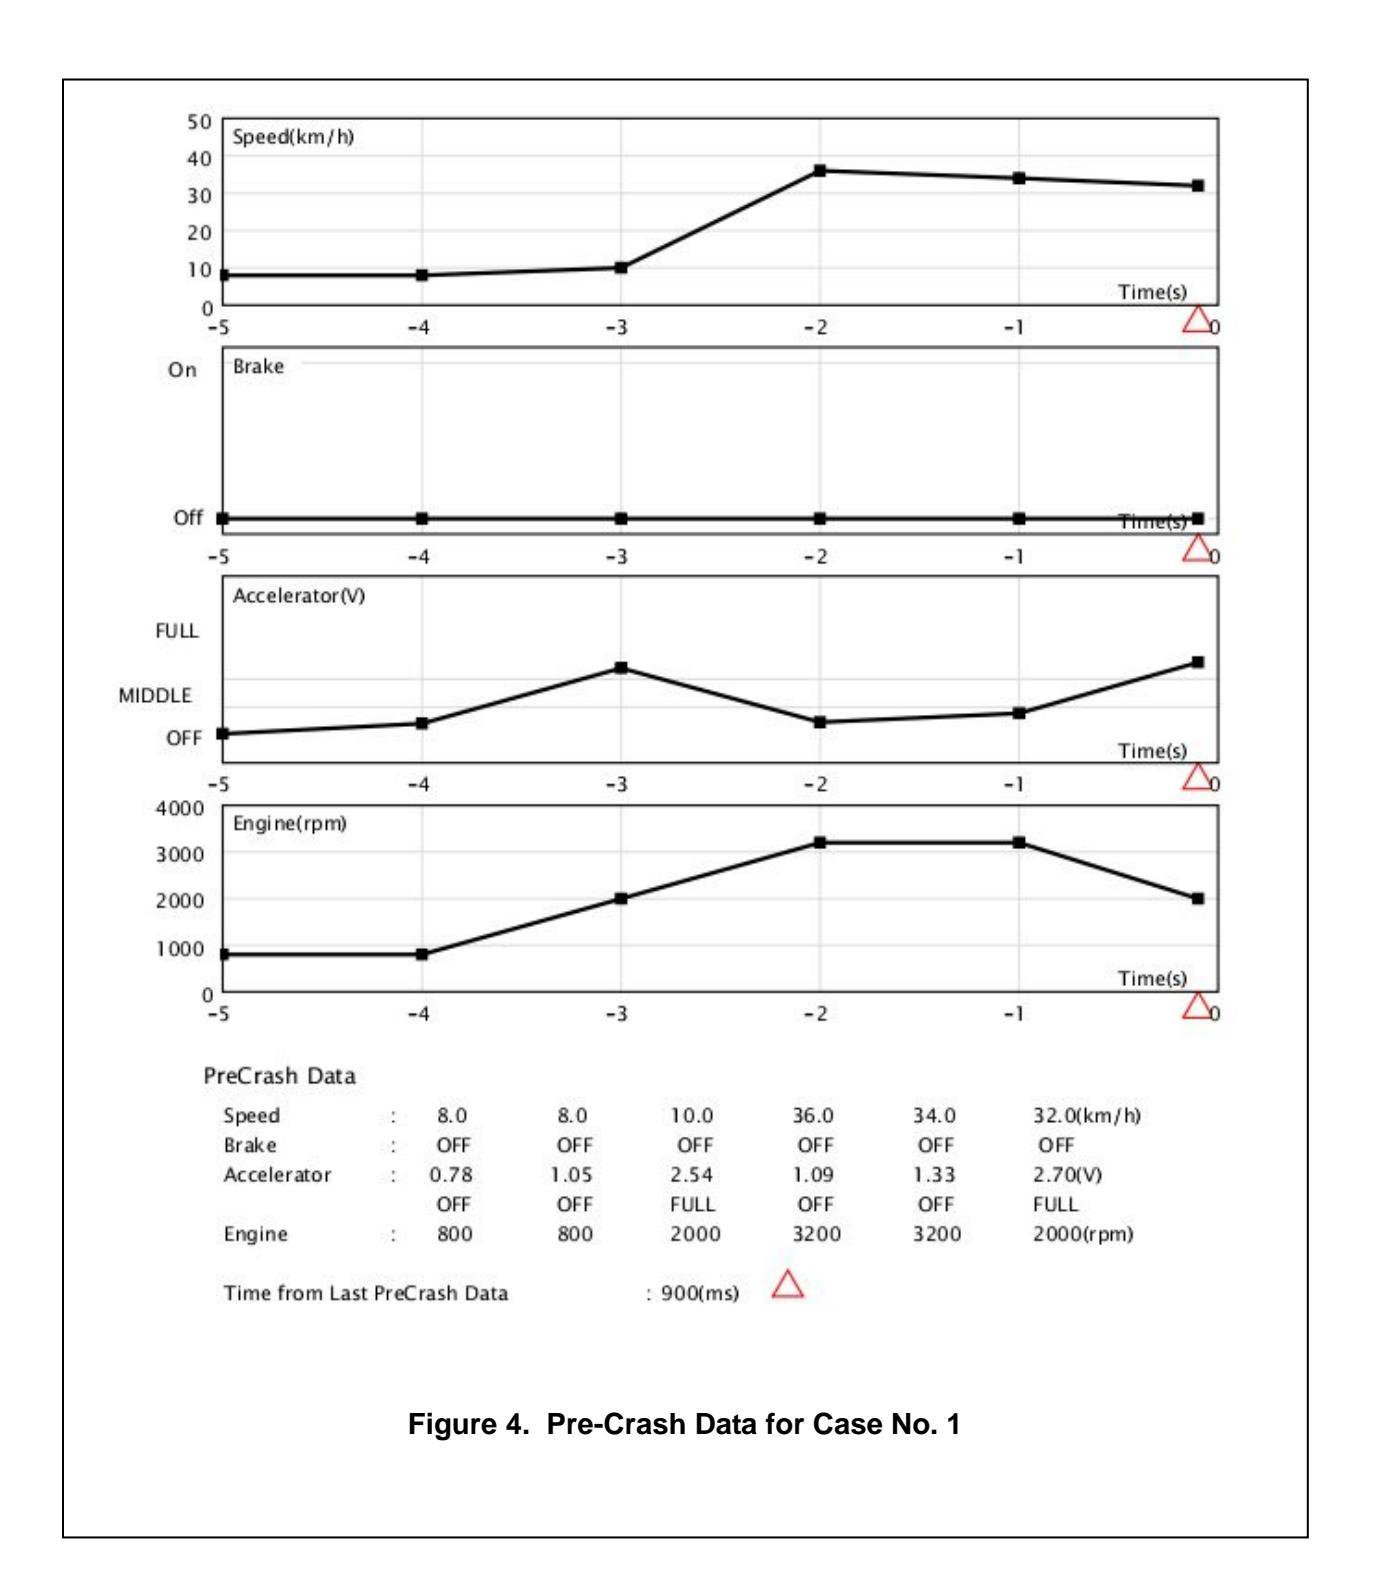
A post-impact inspection of the vehicle did not identify any faults with either the brakes or the throttle system. A brake-hold test confirmed that the brakes would overpower the engine. The vehicle's EDR was downloaded and provided the pre-crash data shown in Figure 4.

Note that, despite the driver's assertions that she pressed on the brake pedal, the brake light switch remains in the off position throughout the recorded incident. Furthermore, there are various levels of effort applied to the accelerator. In particular, note that at t = -3s, the accelerator voltage rises to 2.54 volts, and then drops down in the next two time intervals. However, at the trigger point for the EDR recording (approximately t = 0s), the accelerator voltage is once again relatively high at 2.70 volts. These two accelerator applications may well correspond to the driver's belief that she initially pressed the brake pedal and subsequently pressed harder.

It can also be noted in the pre-crash data that the various levels of accelerator application are accompanied by expected increases in engine speed (RPM) and vehicle speed, subject to time lags between pedal actuation and engine response.

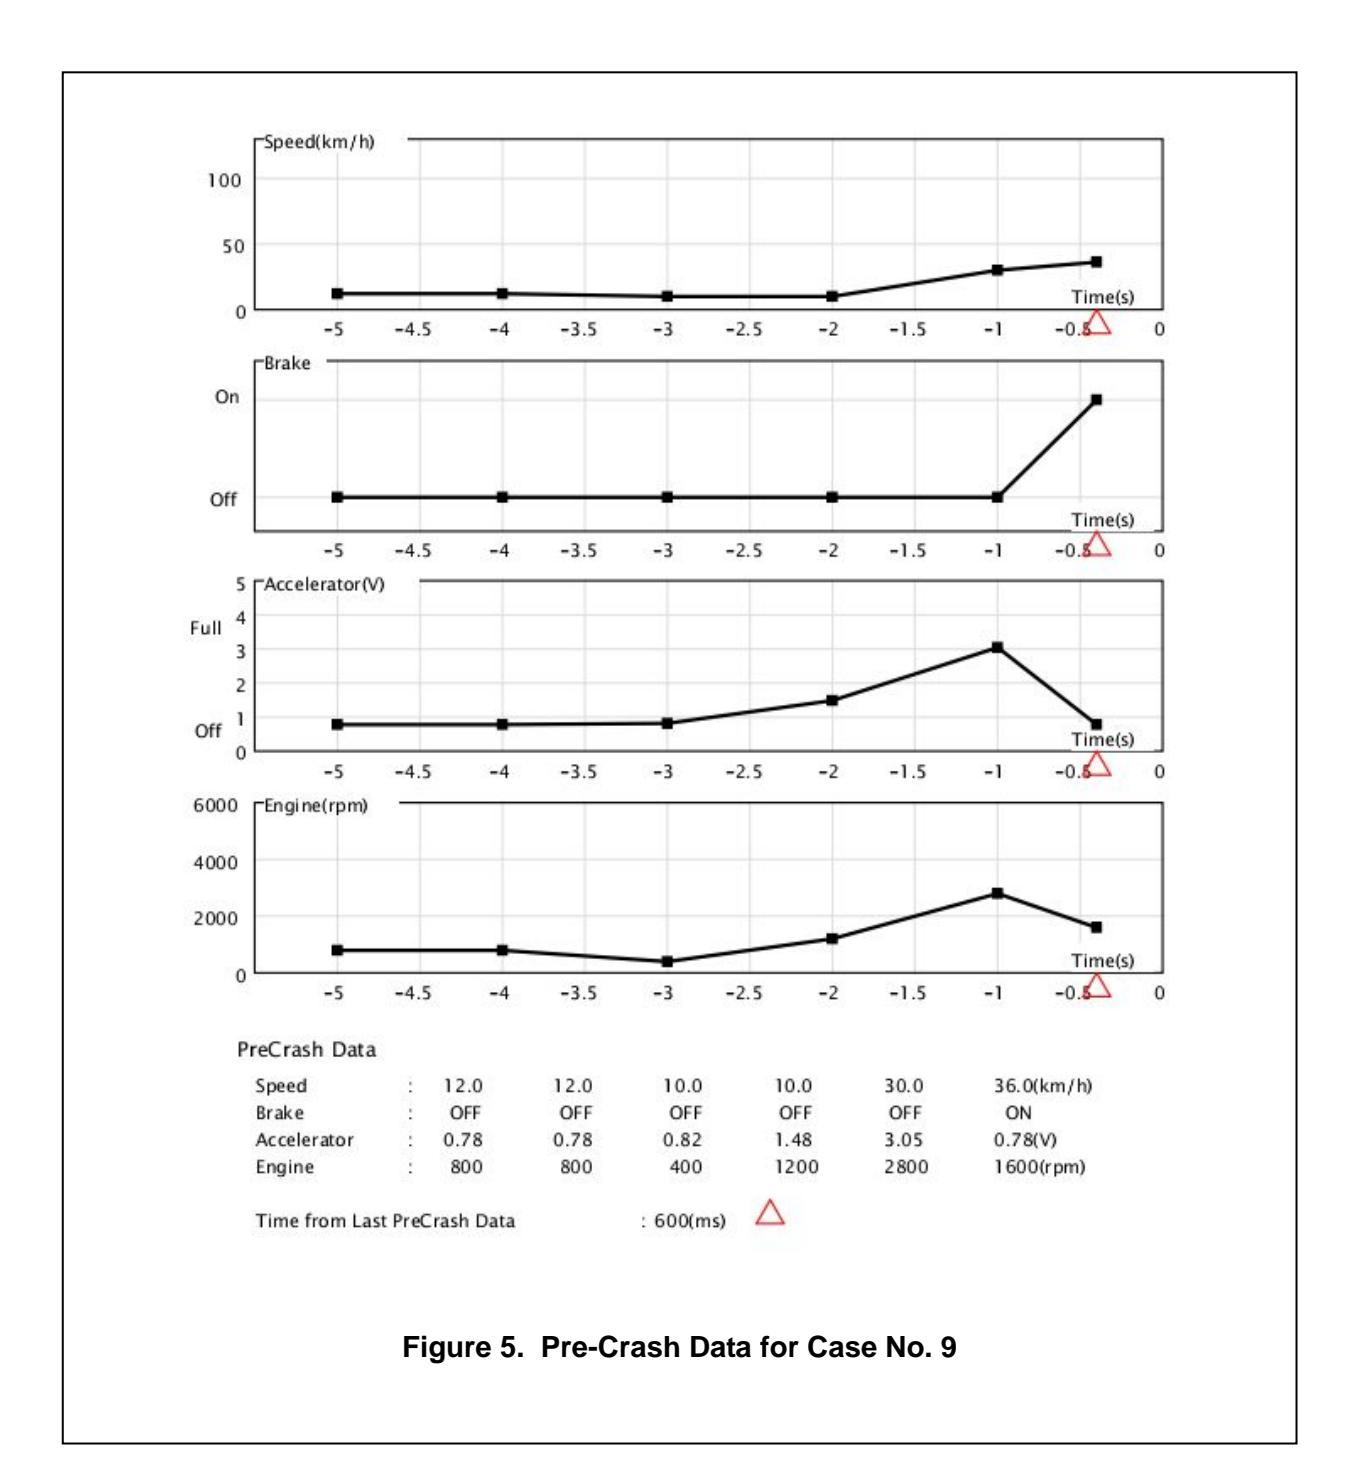
Transport Canada personnel subsequently inspected the vehicle's brake and throttle system and did not identify any problems. An On-Board Diagnostics (OBD) scan did not reveal any fault codes. A brake-hold test confirmed that the brakes were capable of holding the vehicle under a wide-open throttle. The vehicle's EDR was downloaded. The stored pre-crash data are shown in Figure 5.

These data show that the vehicle was initially travelling at approximately 12 km/h (t = -5s), with no brake application, and no accelerator application. At t = -3s, the accelerator voltage rises from 0.78 volts to 0.82 volts, and subsequently to 1.48 and 3.05 volts, indicating rapidly increasing pedal application. As a result, both the engine RPM and the vehicle speed can be seen to increase, with the vehicle's speed reaching 36 km/h at the trigger point for the EDR recording. In the final data interval, the accelerator pedal is shown to have been released and the brakes applied.

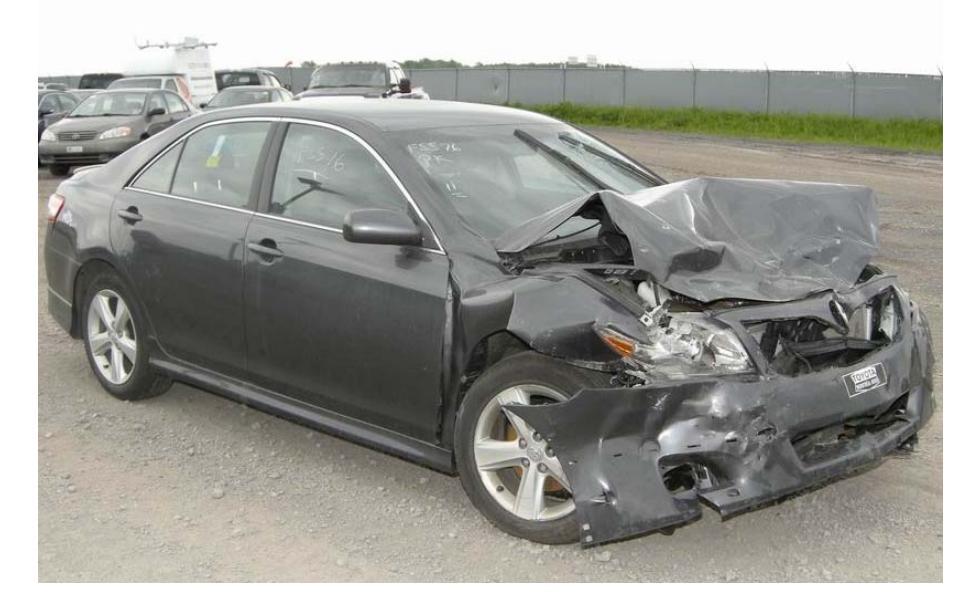
Figure 6. Damage to the 2011 Toyota Camry

The case vehicle, a 2011 Toyota Camry was being operated as a taxi. The male driver arrived at a restricted marshaling area and stopped at a gate controlling access. After obtaining access through the gate, the driver alleges that the vehicle abruptly and very rapidly accelerated. The vehicle continued forward, travelling at high speed, until it impacted a line of parked vehicles and contacted an individual standing next to the struck vehicles. The progress of the fast-moving vehicle just prior to the collision was captured by a security camera.

As can be seen in Figure 7, in the five seconds prior to impact, the vehicle accelerated from 70 km/h to 92 km/h. At no time did the driver apply the brakes. By contrast, in each data interval the recorded accelerator voltage was approximately 3 volts, showing a high level of accelerator pedal application.
