A Study of Pre-Crash Events Using Information Retrieved from Event Data Recorders

Kevin McClafferty ^(a) Paul Tiessen ^(a) Michael Shkrum Multi-Disciplinary Accident Research Team University of Western Ontario

Proceedings of the Canadian Multidisciplinary Road Safety Conference XIII; June 8-11, 2003; Banff, Alberta Compte-Rendus de la XIIIe Conférence canadienne multidisciplinaire en sécurité routière; 8-11 juin 2003; Banff, Alberta

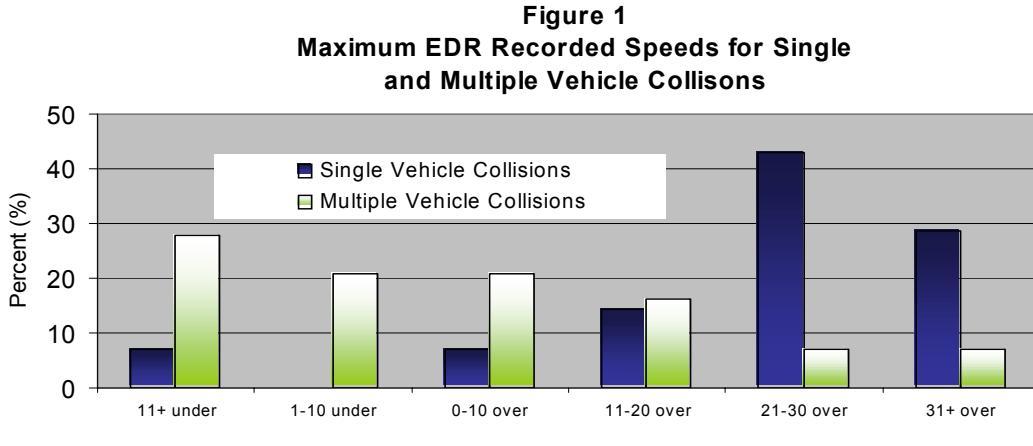
The maximum speed recorded by the EDR in the 5 second pre-crash interval was compared to the posted speed limit and is shown in Figure 1. The maximum recorded speed usually occurred at the -5 seconds to AE interval. Speed differentials below the posted speed resulted from situations such as the EDR equipped vehicle being stopped, or moving slowly in the process of turning left.

The EDR recorded a maximum speed above the posted limit in 60% of the cases, and was most marked in the single vehicle collisions where more than 70% of the vehicles were exceeding the posted speed limit by more than 20 km/h. While most of the multiple vehicle collisions were urban events, the single vehicle collisions frequently occurred on rural roads with higher posted speed limits.

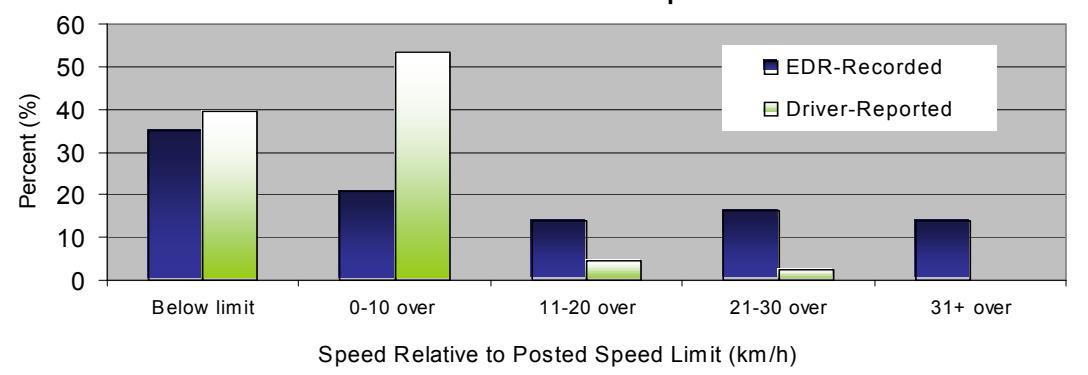
Figure 2 Relationship Between Driver-Reported and EDR-Recorded Speeds

Where possible, driver-reported speeds were determined either by interview or from the police report. In 43 of the cases in our series, both the driver-reported speed and the maximum EDR-recorded speed were available. Figure 2 shows a comparison between these speeds. When drivers

were travelling below the posted speed limit their reported speeds tended to be in relatively good agreement with the EDR. However, drivers frequently under-reported their speed when they were speeding, and most often reported speeds very close to the posted speed limit. Only 3 of the 43 drivers (7%) admitted to travelling more than 10 km/h above the posted speed limit and 2 of these individuals still under-estimated their speed by more than 30 km/h.

Similarly, drivers in this study usually reported speeds at or below the speed limit while the majority of recorded speeds were actually above the speed limit. In 30% of the cases the maximum speed recorded by the EDR was 20 km/h or more above the driver's report. While a driver's perception of the crash events may be quite different than the actual situation, there was an obvious tendency for drivers to misrepresent their speed when they were speeding.

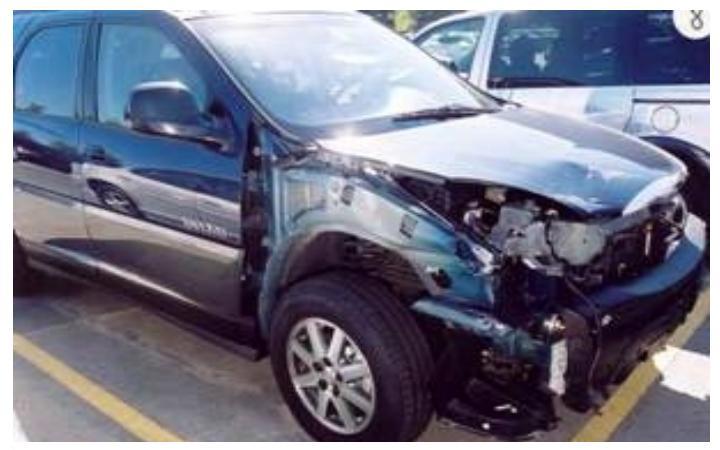
Figure 3 Case vehicle 1

2002 Buick Rendezvous SUV EBS: 19 km/h Driver: 17 yr-F, Lap/torso/airbag, No injury

This T-type collision occurred in daylight at the intersection of an uncontrolled, north-south, fourlane, urban arterial and an east-west, two-lane, stopsign-controlled roadway. The arterial had a posted speed limit of 50 km/h. The Rendezvous was travelling southbound in the right curb lane at a driver-reported speed of 50-60 km/h. A 2002 Pontiac Grand Am 4-Door Sedan was travelling northbound in the left median lane when its driver attempted a left turn at the intersection. The front end of the Rendezvous struck the right side of the Grand Am. The driver of the Rendezvous stated that the Grand Am turned suddenly in front of her and that she braked hard but couldn't avoid the

The EDR indicated a maximum pre-impact speed of 60 km/h. Pre-impact braking was occurring at -1 s to AE. The EDR also indicated that the driver's seat belt status was buckled.

In particular, as exemplified by Case 1 in our series, the versions of events reported by involved drivers were confirmed by the EDR data in the majority of cases. However, there were a number of situations where driver statements were demonstrably inaccurate. In some such cases, as was probably the situation in Case 5, drivers at fault were most likely misrepresenting the truth in order to avoid being charged with an offense. In other cases, drivers held misconceptions about the actual collision events, as was almost certainly the situation in Case 7. Furthermore, as shown by Case 2, the electronic record can provide an important voice, and critical information for the reconstruction of specific crashes, where drivers who are fatally or

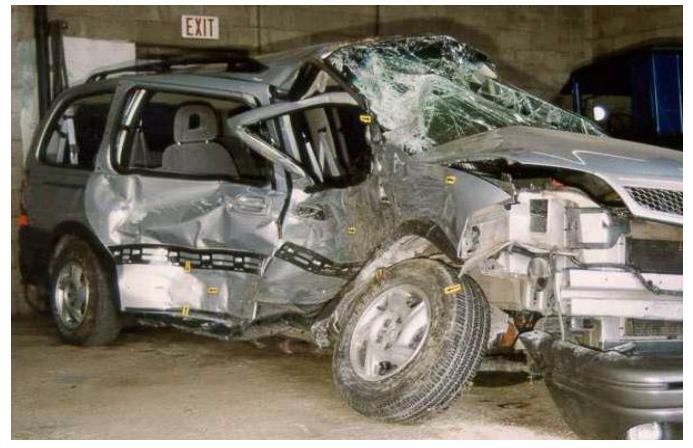
Figure 4 Case vehicle 2

2001 Pontiac Montana Extended Minivan EBS: 45 km/h Driver: 42-yr-M, Unbelted/airbag, Ejection/Fatality

This severe side impact occurred during evening hours at the artificially-illuminated intersection of two multi-lane urban arterials. The weather was clear and the roadways were dry and in good condition. The posted speed limit was 50 km/h for both roadways and traffic was sparse. A witness reported that the minivan was northbound and turned left at the intersection in front of a tow truck. The minivan was struck on its right side by the front of the southbound 1995 Dodge Ram Tow Truck. The unrestrained driver of the minivan was ejected and fatally injured. The EDR confirmed that the driver's seat belt was unbuckled.

Inspection of the pre-crash speed data from the minivan's EDR indicated that it was travelling too quickly to have been in the process of turning left. It was apparent that the minivan was travelling straight through the intersection when it was struck, and that one of the drivers had travelled through a red light. There was no evidence of collision avoidance by the driver of the minivan. The driver of the tow truck had poor recollection of the events leading to the crash but reported to police that he entered the intersection on a green light.

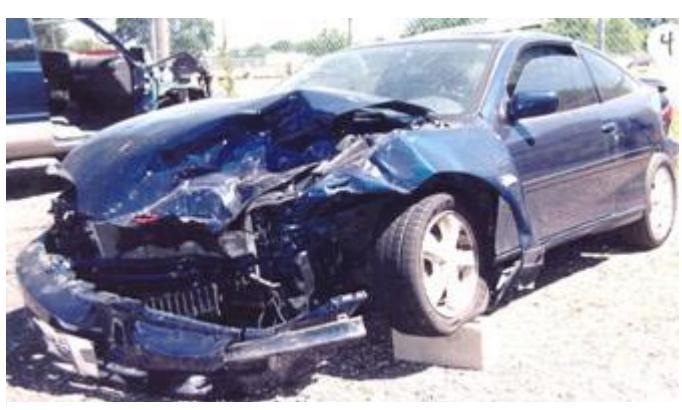
Figure 5 Case vehicle 3

2002 Chevrolet Cavalier Z24 2-Door Coupe EBS: 49 km/h Driver: 22-yr-M, Unbelted/airbag, MAIS-1

This severe frontal impact occurred at the trafficlight-controlled intersection of a four-lane northsouth urban arterial and a four-lane east-west urban arterial. The posted speed limit for both roadways was 50 km/h. The morning rush hour weather was clear and the roads were in good condition and dry. A northbound 1996 Cavalier attempted to turn left at the intersection into the westbound lanes on an amber light. A 2002 Z24 Cavalier was southbound in the right curb lane and also travelled into the intersection on the amber light. The left front end of the 2002 Cavalier struck the right front corner of the 1996 Cavalier.

The brake status reported by the EDR was unusual due to the lack of significant speed loss until the brake status toggled off. Note that it was common in the intersection collisions that the driver of the bullet vehicle applied the brakes just prior to impact. However, in this case, it appeared that the driver stopped braking just prior to impact. It is possible that the driver had his foot lightly on the brake as he approached the intersection and that he braked hard just prior to impact. Interestingly, his foot was not on the brake pedal at -1 s to AE.

The recorded 31% throttle and braking at -4 s to AE was not unusual and the appearance of simultaneous throttle and braking was observed in several other cases. As discussed earlier, the braking and throttle signals are not necessarily synchronized in absolute time so the reported position of the throttle at any given second may not correspond exactly to the status of the application of the brake. Note that the engine speed did not change with the throttle input indicating that the throttle input was very brief. It appeared from the EDR data that the driver was lightly applying the brake and that he attempted to accelerate as he approached the intersection, but quickly changed his mind, possibly when the traffic light turned amber.

The driver of the 2002 Cavalier reported to police that his initial speed was 65 km/h. He did not respond to requests for interview. The vehicle was equipped with ABS brakes and there were no preimpact tire marks. The initial recorded speed of 97 km/h was almost double the posted limit and was a definite factor in the causation and severity of the crash. Both drivers were charged under the Highway Traffic Act with failing to yield the right of way.

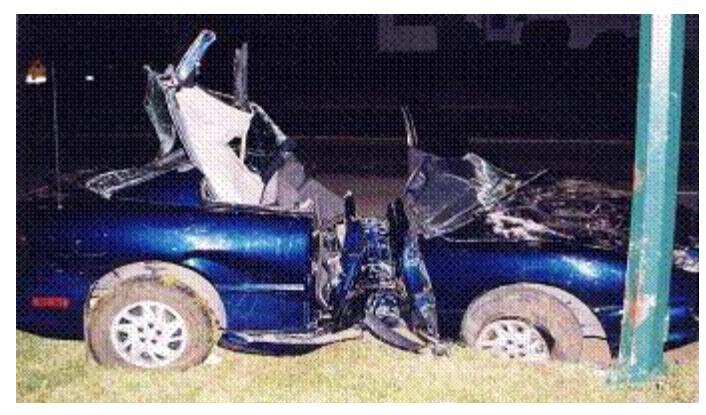
Case vehicle 4

2002 Pontiac Sunfire 2-Dr Coupe EBS: 40 km/h Driver: 16-yr-F, Lap/torso, No injury

This side impact collision occurred in the early morning on a two-way, two-lane, 50 km/h, undivided urban roadway. It was clear and dark and the road surface was dry and in good condition. The Pontiac was westbound in the right lane when the driver lost control in attempting to steer around a parked vehicle on the right roadside. The vehicle skidded sideways into a light standard located on the north side of the roadway. The young female

driver was impaired and had the highest recorded pre-impact speed in the series.

There are a number of considerations in the interpretation of the EDR data in this case. In the -5 and -4 s intervals the vehicle was decelerating beyond the capability of braking alone under high throttle. It appeared that loss of control had already commenced at these points. Note also that the dramatic speed decline from -3 s to -2 s is well beyond the capability of brakes. The recorded speed at -1 s to AE was certainly not representative of the true pre-impact speed of the side-slipping vehicle. While high speed was very likely in this case, there was significant uncertainty regarding the maximum speed provided by the EDR due to the extremely dynamic pre-crash actions of the vehicle.

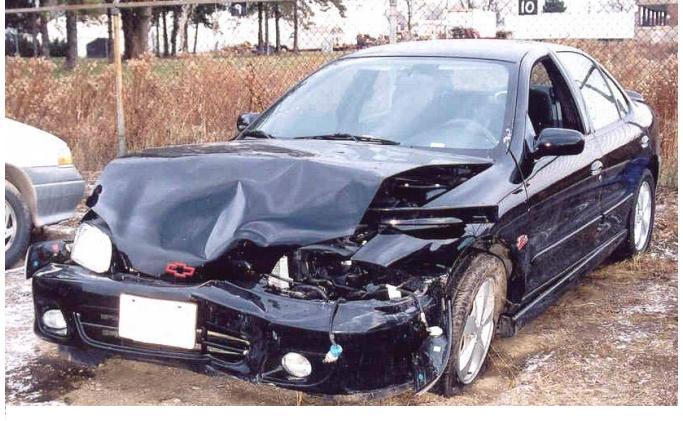
Figure 7 Case vehicle 5

2002 Chevrolet Cavalier Z24 4-Dr Sedan EBS: 27 km/h Driver: 24-yr-M, Lap/torso/airbag, No injury This single vehicle collision occurred on a two-way, 50 km/h, four-lane, undivided urban roadway. It was early morning, dark, and the roadway was artificially illuminated. The weather was active with a rain-snow mixture and the road surface was wet with slush. The driver of the Cavalier attempted to make a right turn onto a secondary residential roadway. The driver lost control of the vehicle which slid across the intersection. The vehicle mounted a concrete curb and then struck a wooden hydro pole with its front end. The male driver had been drinking but was not impaired and no charges were laid. The driver estimated his speed at 50 km/h.

The EDR recorded a deployment level event (pole impact) within 0.3 s after a near-deployment event (curb impact). The near-deployment provided an additional 1 s of pre-crash data at -5 s to AE when combined with the deployment event. The additional 1 s of pre-crash data was vital for the understanding of this crash as it indicated that the driver of the Cavalier was applying full throttle prior to braking and was driving quite aggressively.

The driver was exceeding the speed limit by 29 km/h before he began to slow his vehicle prior to making the right turn. The driver braked and steered the ABS-equipped vehicle but was travelling too quickly to negotiate the turn and apparently did not anticipate the slippery road conditions. The loss of control and subsequent collision were the result of excessive speed and aggressive driving on the slippery road. He was not charged and told police that he was travelling at the speed limit and simply lost control while making a turn on the slippery road surface.

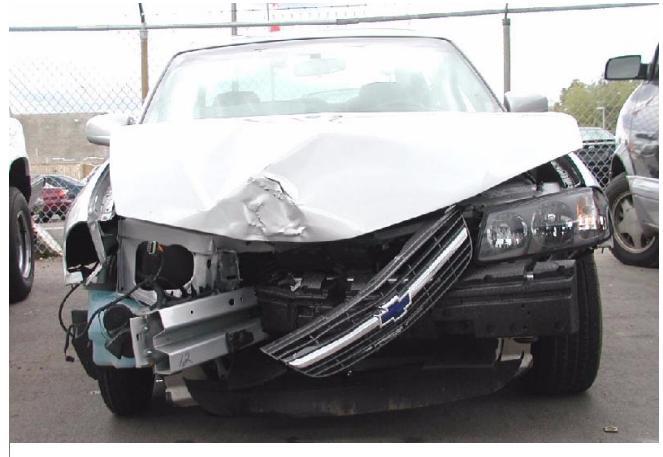
Figure 8 Case vehicle 6

2002 Chevrolet Impala 4-Dr Sedan EBS: 27 km/h Driver: 54-yr-F, Lap/torso/airbag, Not injured

This single vehicle collision occurred at night in heavy rain at an artificially-illuminated intersection. The southbound Impala was stopped at a Tintersection with an east-west urban arterial. The driver of the Impala attempted a right turn at the intersection into the westbound lane. Witnesses reported that the Impala accelerated quickly, apparently to avoid approaching westbound traffic. The vehicle turned abruptly to the right, as result of the steering and heavy throttle input, and travelled onto the northwest roadside. The vehicle continued on the roadside for 12 metres narrowly missing a wooden hydro pole before striking a 35 cm. diameter tree with its front end. A maximum velocity change of 33 km/h was recorded by the EDR.

The EDR indicated that the driver did not brake prior to impact, but rather was applying full throttle. Police reported that this hard acceleration was intentional. The driver was not familiar with the base model rental vehicle and apparently did not anticipate the vehicle reaction when she accelerated quickly on the wet asphalt. She had consumed 1.5 glasses of wine prior to the incident.

The EDR indicated that the driver was applying 100% throttle at the -2 s and -1 s intervals. The recorded speed increased dramatically from 18 km/h (11 mph) at -3 s to AE to 61 km/h (38 mph) at -1 s to AE. The front wheels were evidently slipping considerably as the vehicle would not be capable of such a large acceleration. Based on the damage to the vehicle, the impact speed was estimated as being well below 61 km/h, providing further evidence of considerable wheel slip at impact. The recorded speed at -1 s to AE was

certainly not representative of the true vehicle speed.

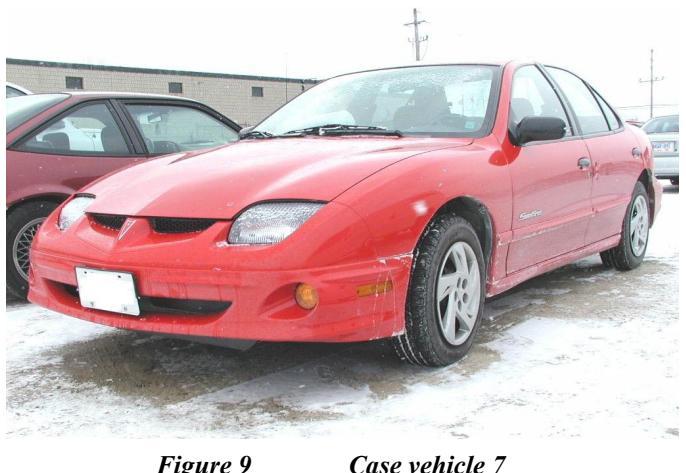
Figure 9

2001 Pontiac Sunfire 4-Door Sedan EBS: 8 km/h Driver: 27-yr-F, Lap/torso/airbag, No injuries

This very low severity frontal impact occurred during the late afternoon hours in a parking lot. It was daylight and the weather was active with snow and strong winds. The parking lot had icy patches covered with snow. The Sunfire was travelling through the parking lot at low speed and entered an assigned parking spot. The driver of the Sunfire stated that she braked hard and then the airbags deployed. She also reported that the Sunfire came to rest a short distance away from the wall and that the wall was not struck. The Sunfire sustained no measurable damage to its front end.

The EDR recorded a maximum delta-V of 8 km/h at 90 ms A license plate imprint was identified on the concrete wall adjacent to her parking place. While there was indeed a collision, the impact was of minor severity and did not warrant airbag deployment.

The pre-crash data for the Sunfire indicated a very low vehicle speed of 3 km/h at each of the 5 sampling intervals. Braking was recorded at the -2 s to AE interval only. The throttle increased from a constant 4% to 22% at the -1 s to AE sampling interval indicating that the driver accelerated just prior to impact. It appeared that she increased the throttle in an attempt to park the vehicle on a slick icy surface, and her vehicle picked up speed when her tires came into contact with a higher friction surface. The impact speed was calculated to be in the 4 to 7 km/h range.
